STEPHEN F. AUSTIN ELEMENTARY

EXECUTIVE SUMMARY

EXISTING SITE ASSESSMENT FORM

EXISTING EXTERIOR BUILDING ASSESSMENT FORM

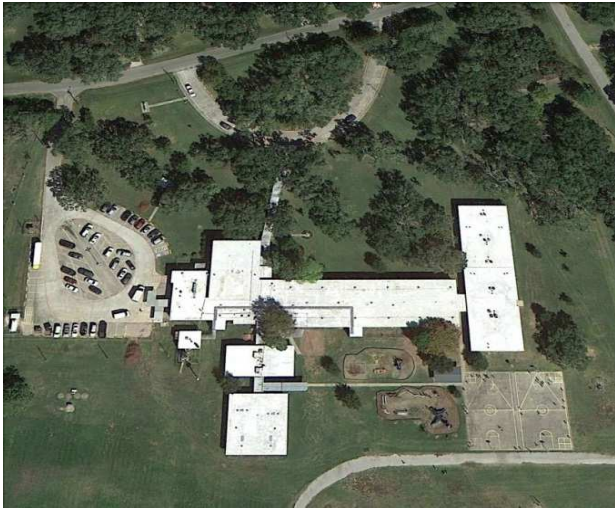
Special Notes or Observations
Ponding water in multiple areas
Ponding water, bar ditch at entry for drainage
Exposed gas line
low hung power lines
Site lighting uneven across drive/parking, canopy lights exist
Entry paving is good, asphalt road, concrete parking/fire lane
Several ponding water locations
Trees overhang fire lane and roof
Grasses growing in gutters, not maintained
Concrete parking, and asphalt drive
Cracking/decomp asphalt and water ponding @ staff parking.
Concrete fire lane. Non-uniform lighting around fire lane
Parking striping illegible
Inadequate visitor parking, all parallel spots
Poured-in-place curb on 1 side of drive, vehicle stop on other side
Minimal sidewalks, none connect to doors,not accessible.
Cracking, uneven sidewalks.
Basketball court in fair condition, minimal cracks, damaged goals
Asphalt running track with some ponding
1/2" offset around paving not accessible. Minimal cracking

Basketball backboards cracking w/poles in fair condition
Play area in fair condition. Not accessible.
Open playground
Not accessible, needs ramp
Decomposed mulch with grass growing. Base lining decomposing.

Non-uniform lighting at firelane. Minimal lighting typ.
 No fencing around site. No security vestibule at entry
 None evident.
 No overall site fencing. Req'd for site security
 No fencing. Req'd for site security
 No retaining/screen walls.
 within staff parking lot. Not screened.
 No directional site signage. HC sign at parking. Marquee sign good.
 Rusting and bent picnic tables
 Non-compliant entry ramp & site circulation . No HC parking
 Not compliant. Sidewalks do not extend to doors.
 No ramps on property.
 No handicapped accessible parking
 None available
