# LANIER MIDDLE SCHOOL

## EXECUTIVE SUMMARY

The main Lanier MS building was completed in 1995 with a new addition in 2007 and is in good condition overall. A majority of classrooms meet TEA minimum standards, and finishes in the older facilities are in fair to poor condition. The external gymnasium building provides uncontrolled points of entry. The original gym is over 60 years old and most systems have outlived their useful service life and should be replaced.

**RECOMMENDATION:** Due to age, arrangement and security as identified above, the original Gymnasium should be removed and be replaced. The 1995 & 2007 Middle school is a functional and useful facility, needing minor improvements to meet codes, such as life safety and accessibility. It is recommended to upgrade finishes and renovate the restrooms in the 1995 facility as well.

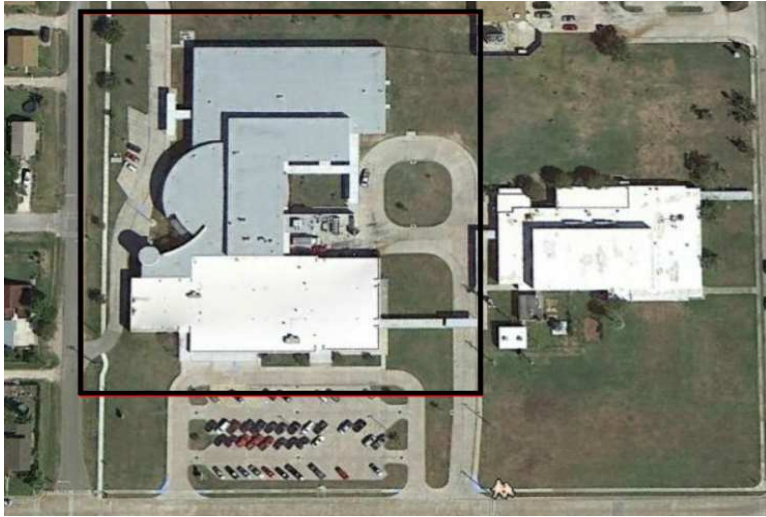
Floor Plans

INTERIOR BUILDING AREAS	
<b>Circulation:</b>	Ample circulation
<b>Interior signage:</b>	Room signage. No directional signage.
<b>Layout:</b>	The building is laid out in 2 wings: 5th & 6th grade wings Kitchen/Cafeteria is central

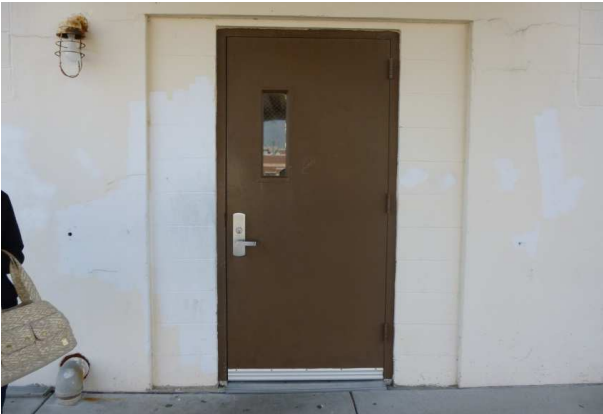
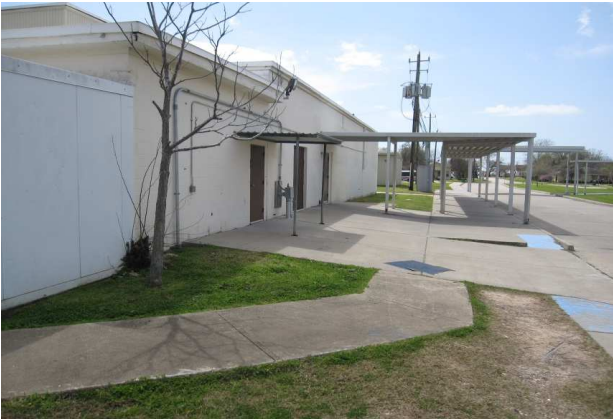
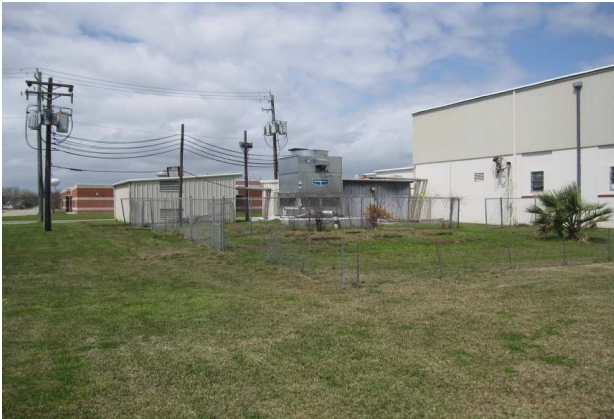
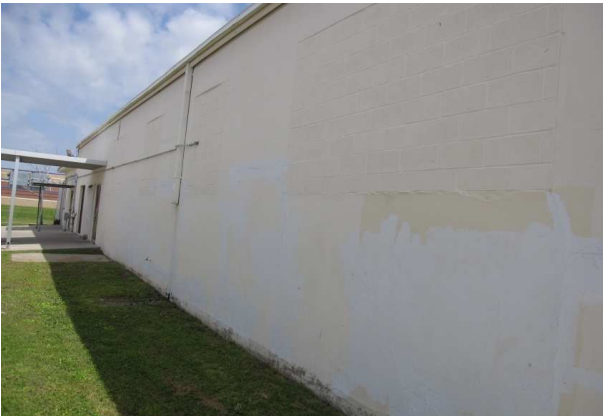
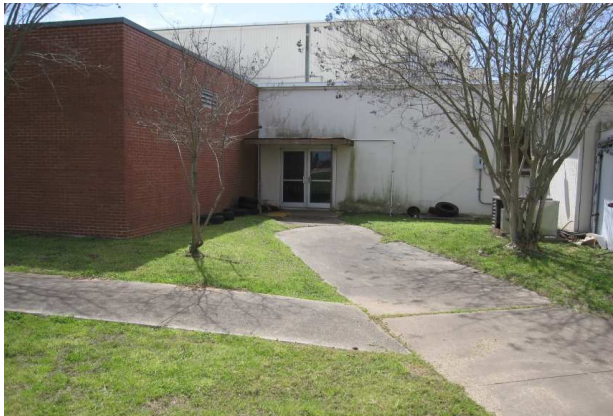
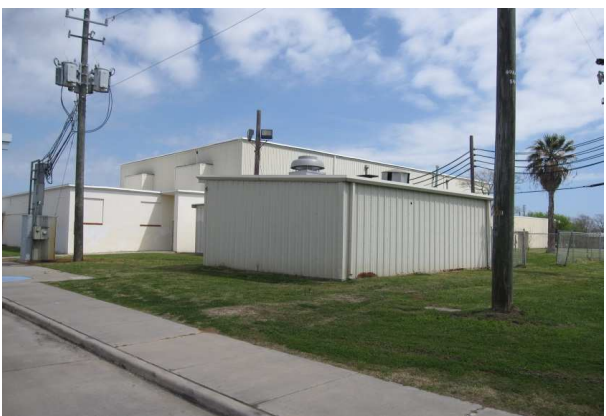
## OLD GYM - 1950

General Notes:	
<b>Exterior Building Condition</b>	
<b>Exterior Envelope</b>	
Wall Condition	Recent addition in good condition. Existing Gym/Velasco poor
Window Condition	Alum. Windows--1995/2007: double pane glass, 1950:
Doors/Entrances	Aluminum storefront doors in good condition at 2007
Secure Entrance	No security vestibule. Admin at entry.
<b>Foundation/Structure</b>	Good to fair building structure/foundations.
<b>Roofing Areas</b>	Fair condition/maintenance required
Existing Warranty	Unknown at this time
Area for repair	Maintenance is needed for the modified roof areas.
Area for Replacement	Replacement is needed for the single ply areas
<b>Exterior Building Lighting</b>	Wall packs & exterior pole lighting.
<b>Kitchen dock/loading entry</b>	Good condition.
<b>Canopies</b>	Avadek canopy w/ lighting
<b>Additional information</b>	Existing Gymnasium & old Velasco ES in poor condition. Needs to be demo'ed and replace Gym.

Special Notes or Observations
Recent addition in good condition. Existing Gym/Velasco poor
existing gym painted CMU walls need repainting
Alum. Windows--1995/2007: double pane glass, 1950: single pane
Good condition - newer windows / Poor condition at gym
Aluminum storefront doors in good condition at 2007 addition.
HM Door/frame at kitchen entry rusting
Good/Fair condition-2007 addition ; Poor - existing gym
Avadek canopy w/ lighting
Wall packs & exterior pole lighting.
No security vestibule. Admin at entry.
Good condition.

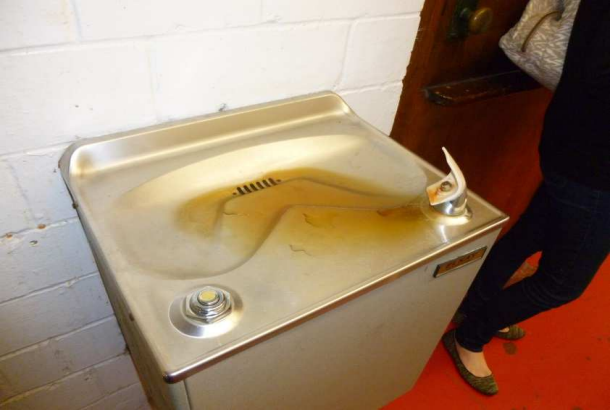
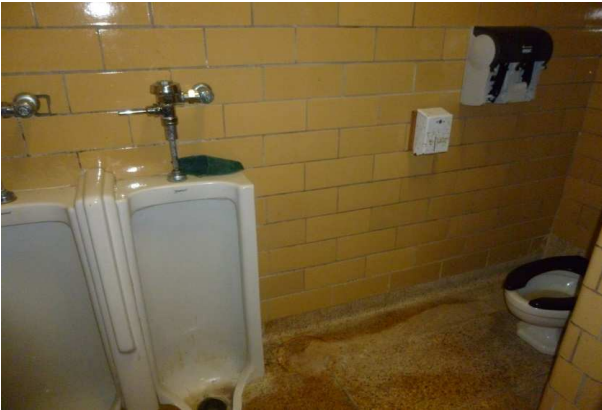
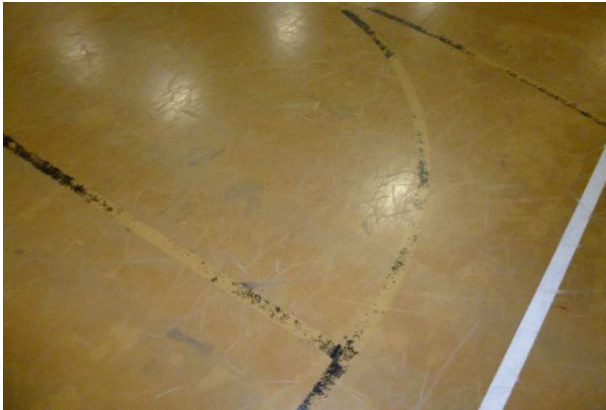
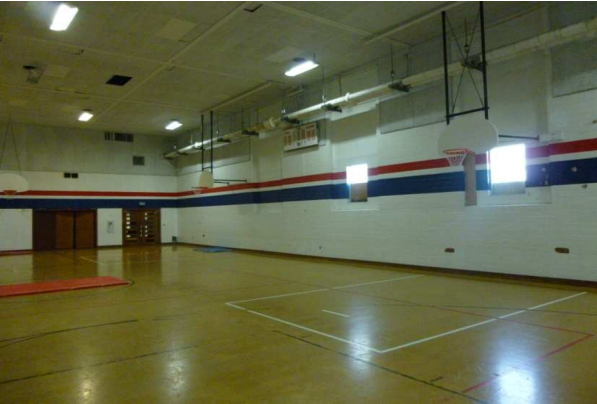
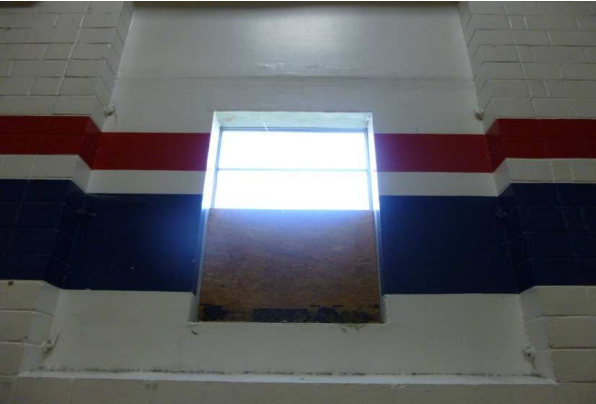
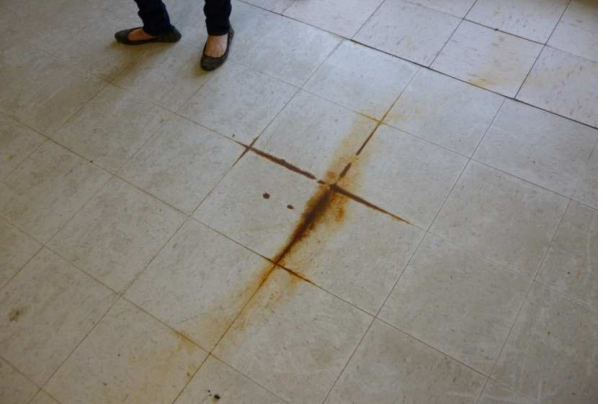
## OLD GYM - 1950

Some missing/broken ceiling tiles at old gym.

Some leaking at old gym.

tile at restrooms  
 stage at old gym; poor condition  
 at old gym only

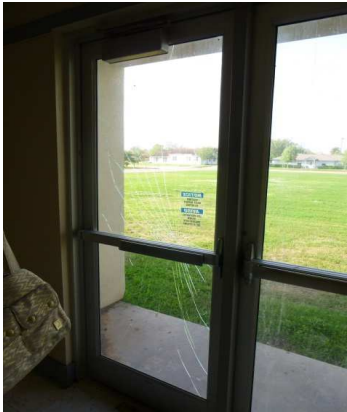
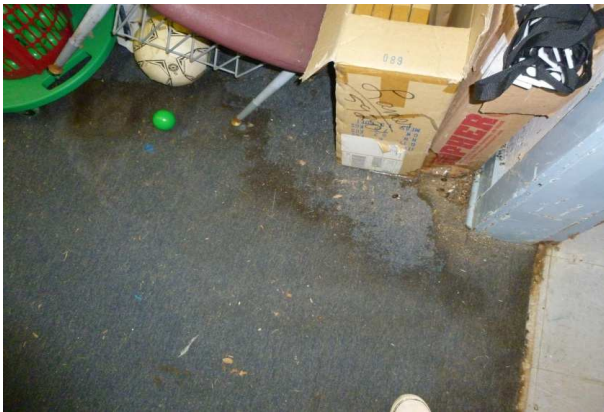
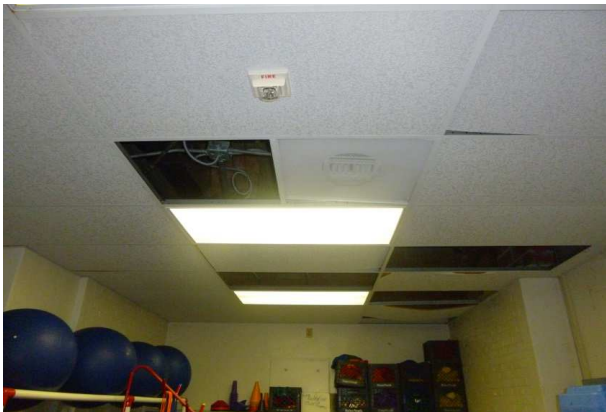
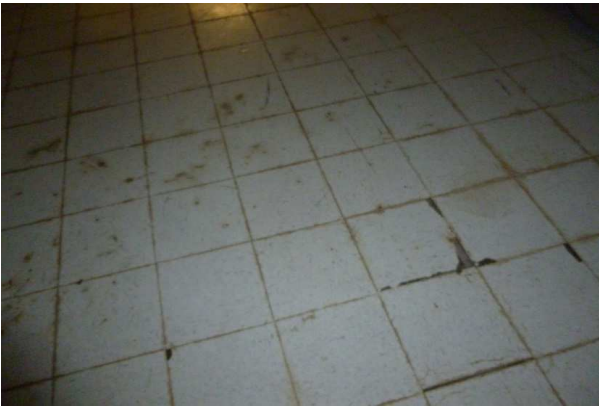
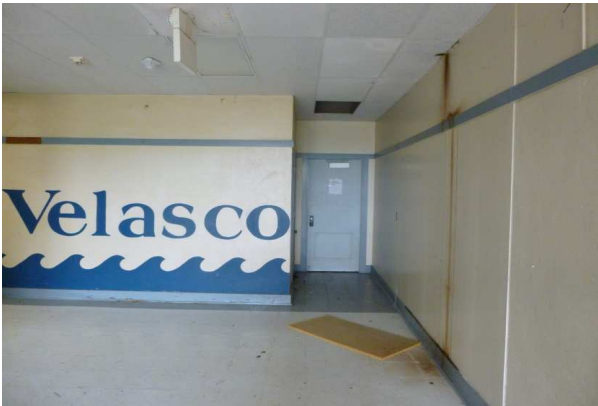
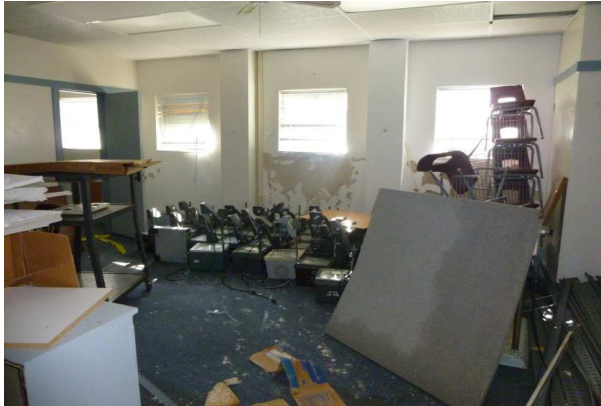
## OLD GYM - 1950

Most RRs accessible. Old gym are non compliant.
