Brazosport Independent School District
Long Range Facilities Planning Committee Meeting
May 14, 2014

2014 Bond Program

FACILITY CONDITION ASSESSMENT

2014 BISD FACILITY

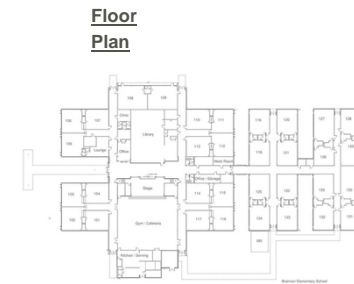
BESS BRANNEN ELEMENTARY SCHOOL

Overall Score : 3.76

Major Deficiencies:

- Mechanical; Replace Cooling Tower, RTUs
- Plumbing; Replace Galvanized Piping
- Security; lacks entry vestibule, exterior access to portable
- Lacks Fire Sprinkler System
- Nearly half of Classrooms do not meet TEA Standards
- Electrical Power; Inadequate
- ADA; lacks Parking at Entry Drive, Restroom, Sinks, Signage
- Outdated, undersized Kitchen and
- Foodservice Equipment

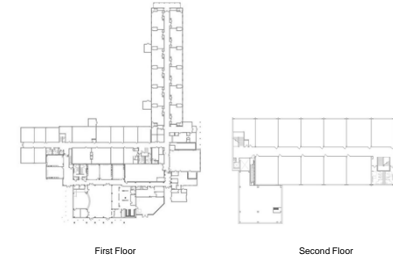
Floor Plan

Overall Score : 3.82

Major Deficiencies:

Exterior Walls/Windows; fair to poor condition
ADA Accessibility; restrooms, clearances
Site Drainage
building
Approx. 1/3 of Classrooms do not meet TEA minimum stds

Mechanical; replace RTUs, piping & insulation
Electrical; inadequate power/data
Plumbing; replace galvanized piping in older building
Lacks Fire Sprinkler System

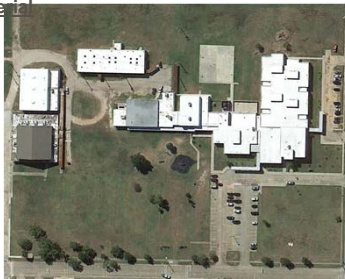
Site Aerial

Overall Score : 3.29

Major Deficiencies:

- Security; exterior access to Cafeteria, fencing, lacks vestibule half of AHUs
- Gymnasium construction older, non ADA compliant
- Some classrooms do not meet TEA minimum standards piping
- Kitchen; equipment in fair/poor condition

- Mechanical; Replace RTUs,
- Lacks fire sprinkler system
- Plumbing; replace galvanized

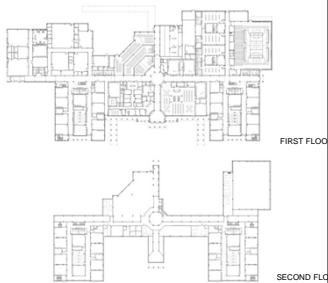
Floor Plan

Overall Score : 2.18

Major Deficiencies:

Security; lacks vestibule, fencing
Roofing; replace Gym roofing

ADA Accessibility; outdoor athletic areas, outbuildings

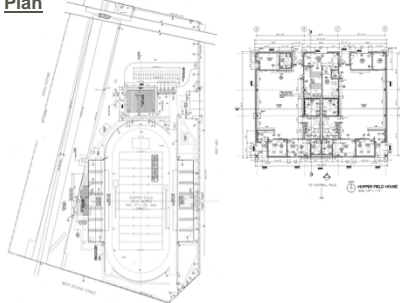
Floor
Plan

Overall Score : 2.49

Major Deficiencies:

- Restrooms; additional restrooms required for current code
- Offices
- Lacks fire sprinkler system
- ADA Accessibility; Ticket Booth, Athletic
